Reflective Cracking Testing Notes

Date: March 15, 2017

Project: Reflective Cracking Indoor Phase 5

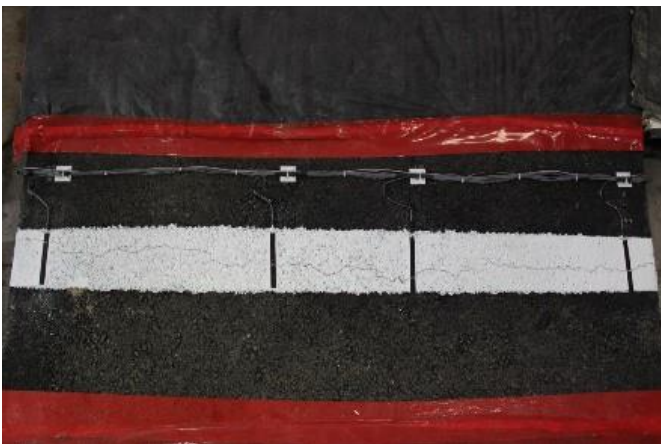
- Outer vertical edge:
 - No visual changes were observed.
- Joint surface area:
 - The surface crack is a little more noticeable as shown in Figure 1.
- Inner vertical edge:
 - No visual changes were observed.

Figure 1. North test section surface crack.

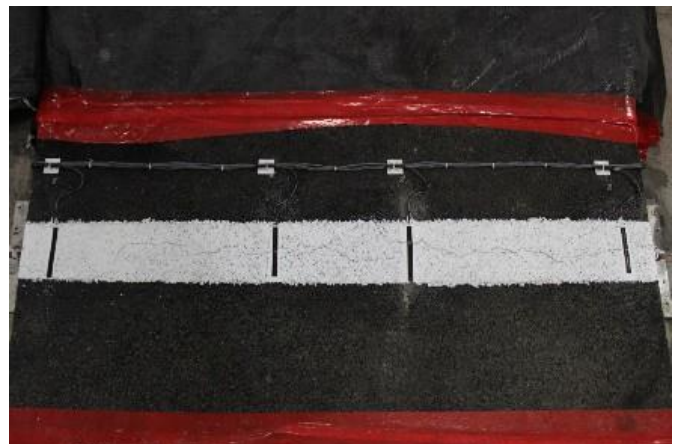
- Outer vertical edge:
 - No visual changes were observed.
- Joint surface area:
 - The surface crack is a little more noticeable as shown in Figure 2.
- Inner vertical edge:
 - No visual changes were observed.

Figure 2. South test section surface crack.
